Using Sound Insulation Software To Predict Non-Achievement Of Performance Standards

Peter Heinze

Marshall Day Acoustics, P O Box 5811, Wellesley Street, Auckland

A paper previously presented at the 16th conference of the New Zealand Acoustical Society, Auckland 2002.

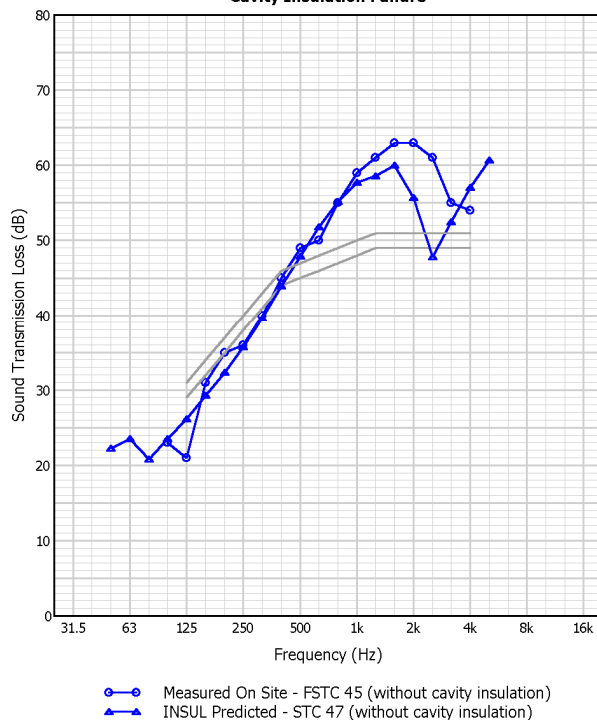
A Winstone Gib GBT(L)A 90r STC 55 wall (refer Table 1) was specified for the inter-tenancy walls in an apartment complex. However, when on-site compliance measurements were carried out the results were typically FSTC 45, as shown in Figure 1A.

SIPS was used to predict the performance for this wall construction, without cavity insulation. A prediction of STC 47 and the shape of the transmission loss (TL) curve closely approximate that of the on-site failure curve (refer Figure 1A).

Figure 1A: Single Stud Resilient Rail Wall
Gib GBT(L)A 90r - STC 55
Cavity Insulation Failure

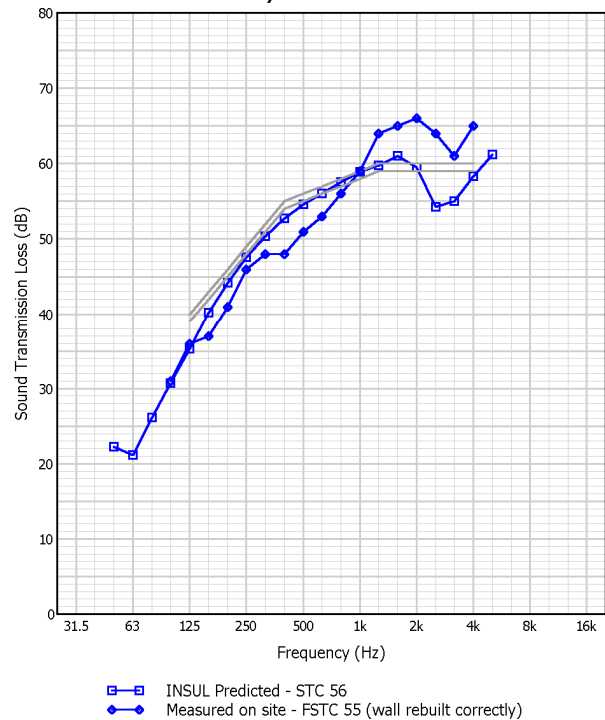
The wall was re-built with cavity insulation and retested. Figure 1B shows the SIPS predicted rating for the specified wall construction, STC 56, and the re-measured wall results (FSTC 55) following

Figure 1B: Single Stud Resilient Rail Wall
Gib GBT(L)A 90r - STC 55
Cavity Insulation Included

inclusion of cavity insulation. Close observation during re-build, and masonry floors helped to minimise flanking paths and result in a satisfactory on-site sound insulation performance.

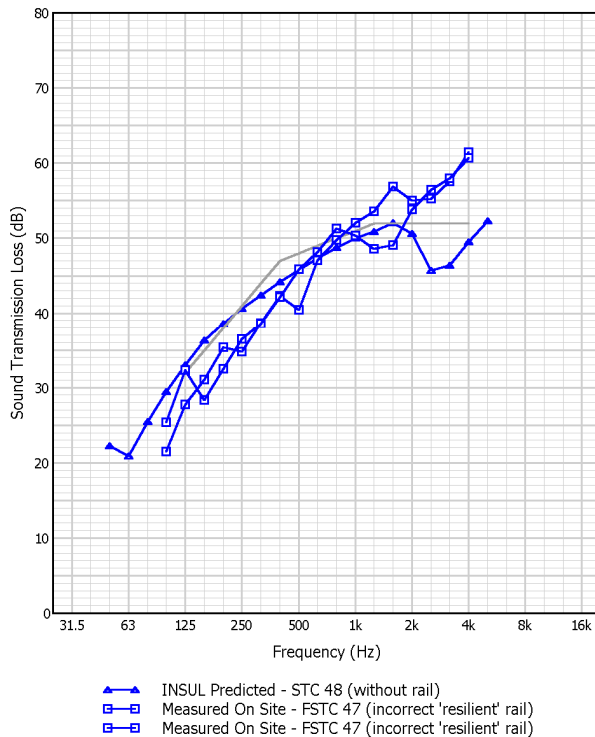
Figure 2A: Single Stud Resilient Rail Wall
Gib GBT(L)A 60 - STC 55
Incorrect Resilient Rail Failure

A Winstone Gib GBT(L)A 60a (refer Table 1) with measured performance of STC 55, was specified for an apartment project which however resulted in on-site failure due to substitution of a non-conforming resilient rail.

In Figure 2A, the measured on-site performance of two walls are shown with a measured sound insulation performance of FSTC 47. This rating falls short of the minimum NZ Building Code criterion (FSTC 50). Also, shown in Figure 2A is the SIPS prediction (STC 48) for the same wall

construction without a resilient rail. The shape of the on-site and predicted TL curves closely approximate each other between 100 and 2,000 Hz.

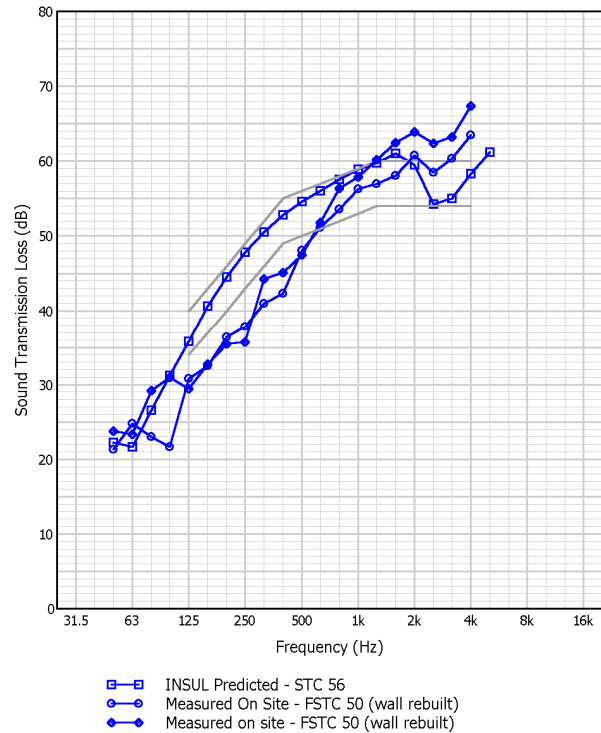
Figure 2B: Single Stud Resilient Rail Wall
Gib GBT(L)A 60 - STC 55
Correct Resilient Rail Used

The walls were rebuilt with the correct resilient rail installed and follow up measurements confirmed that the NZ Building Code criterion was met (i.e. FSTC 50 measured on-site). Figure 2B shows these results including the SIPS sound insulation performance rating (STC 56) of the wall. The prediction and on-site performance TL curves closely approximate each other when allowing for on-site losses due to flanking and construction techniques.

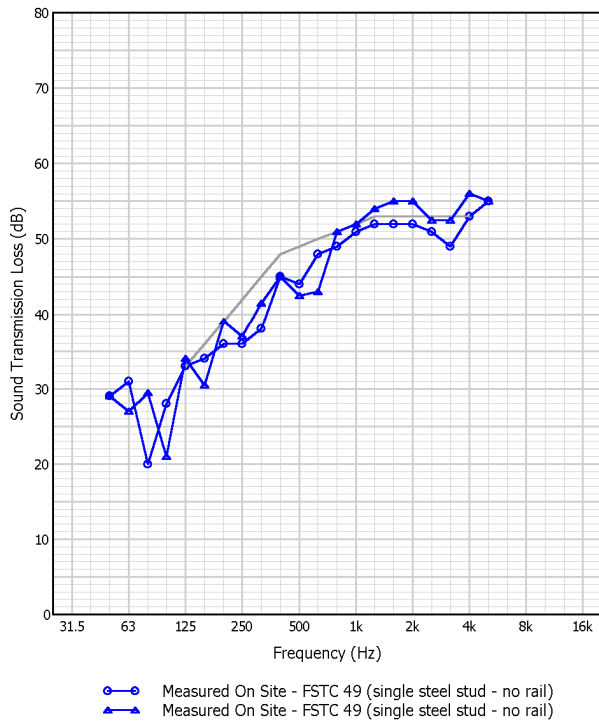
For this particular apartment complex, Elephant Plasterboards EPSA60b with a measured performance of STC 56 were used for the construction of the inter-tenancy walls (refer Table 1). On-

site measurements revealed performances of typically FSTC 49. The measured on-site results are shown for two walls in Figure 3A. The measured on-site result is also repeated in Figure 3B along with the SIPS rating for this construction, STC 55. A possible solution to meet the NZ Building Code is the provision of an additional sheet to one side of the partition on-site (SIPS predicted STC 58).

Figure 3A: Single Steel Stud Wall
EP EBSA60b - STC 56
FSTC Failure

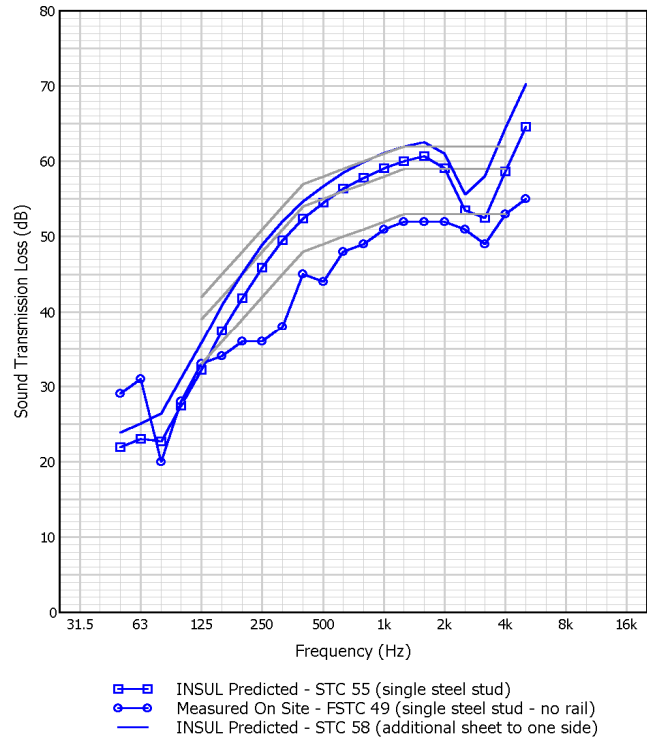
From a number of tests of single stud partitions, both within the laboratory and on-site, allowing for the vagaries of flanking transmission and construction techniques, indicates that resilient rails are required on single stud walls in order to meet the minimum criterion. SIPS also predict STC 55 for this Elephant Plasterboard wall construction. However the SIPS is a prediction tool and, as noted above, complying and maintaining the on-site minimum performance criterion is very difficult without the inclusion of resilient rails. The

Figure 3B: Single Steel Stud Wall
EP EBSA60b - STC 56
Predicted & Measured On Site

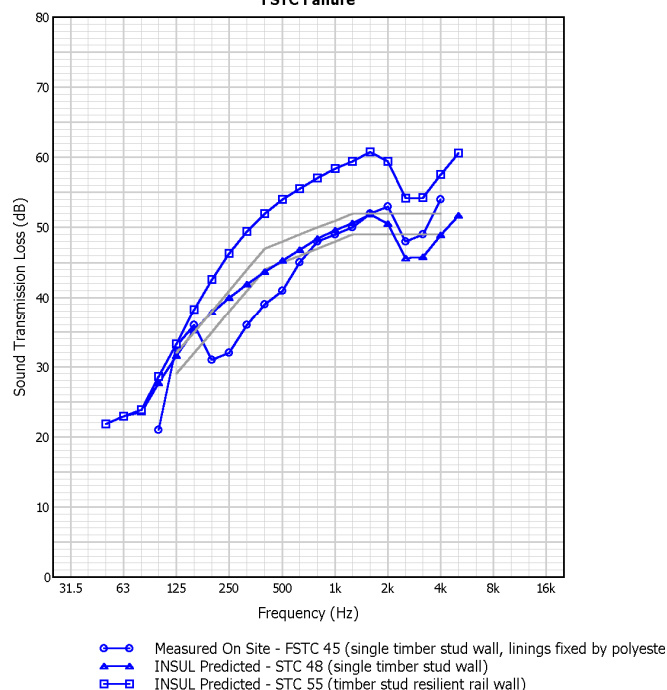
frequency range in which the resilient rail is performing in conjunction with a single stud wall is clearly shown in Figure 4A and corresponds to the test frequency range for on-site testing.

For this apartment complex the builder had recommended as an alternative to the specified resilient rail STC 55 wall the use of a CTS Plasterboard Products type TGLA60p wall construction which has a documented rating of STC 55. As described in Table 1 the wall linings are connected to the studs through Polyester strips.

The measured on-site performance of FSTC 45 for this wall construction is shown in Figure 4A. Also, in Figure 4A is the SIPS rating for this wall of STC 48 based on the wall linings directly fixed to the timber stud. There is very close agreement between the predicted and on-site TL's, except for a notable reduction around 250 Hz for the on-site performance, most likely due to some form of

Figure 4A: Single Timber Stud Wall - Linings Fixed Through Polyester Strip
CTS TGLA60p - STC 55
FSTC Failure

resonance.

The same wall construction with resilient rails replacing the polyester strips is shown in Figure 4A with a predicted rating of STC 55. For this apartment complex the originally specified walls with resilient rails were installed.

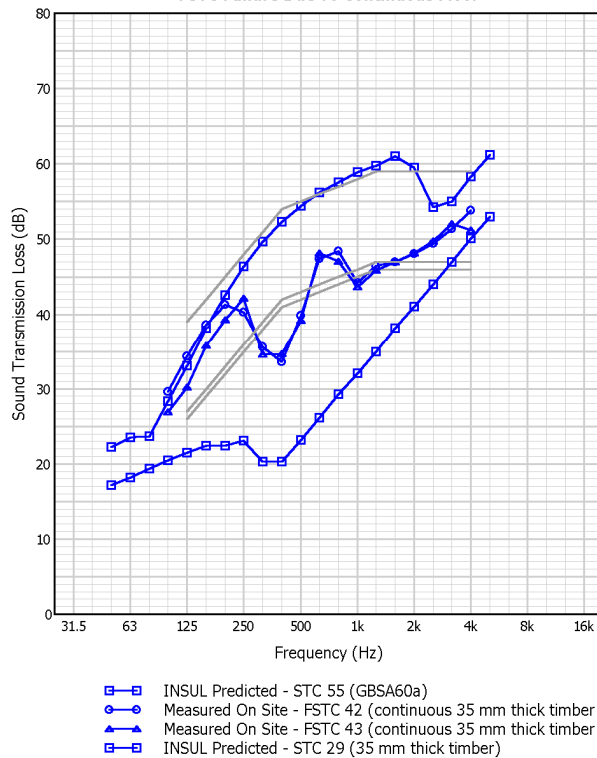
maintained and refurbished. The inherent problem of continuous floors on the sound insulation performance of wall systems is well known and documented, and despite this a number of apartments are still being constructed on continuous floors. On a recent project a Winstone Gib GBSA60 wall (refer Table 1 and Figure 5A) with a measured performance of STC 55 was installed in a refurbished apartment building.

The measured on-site results as described in Figure 5A, revealed significant non-

compliance with the NZ Building Code criterion where results of FSTC 42 and FSTC 43 were obtained. The shape of the on-site sound transmission loss curve indicated a significant dip in the curve occurring at 400 Hz. The existing flooring, a 35 mm thick tongue and groove timber was modelled in the SIPS and its TL curve is also shown in Figure 5A. The coincidence dip for this flooring system coincided with those for the measured results on-site.

Figure 5A: Steel Stud Resilient Rail Wall
Gib GBSA60a - STC 55
FSTC Failure Due To Continuous Floor

Following rectification works, where a saw cut was placed in the timber floor directly below the

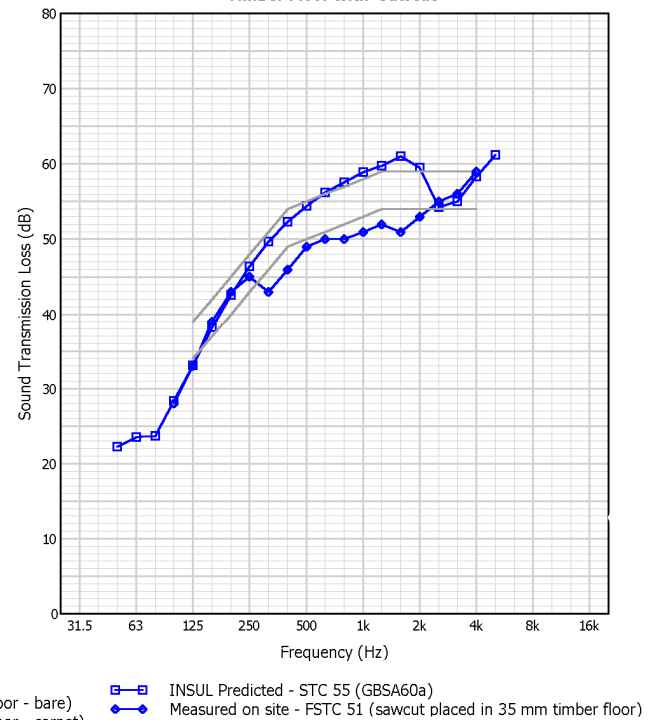
Figure 5B: Steel Stud Resilient Rail Wall
Gib GBSA60a - STC 55
Timber Floor with 'Sawcut'

resilient rail, and in accordance with typical Winstone junction details, the wall was re-measured

and an on-site performance of FSTC 51 was achieved. The results of this test and the SIPS

performance of STC 55 for the Gib GBSA 60a wall are shown in Figure 5B.

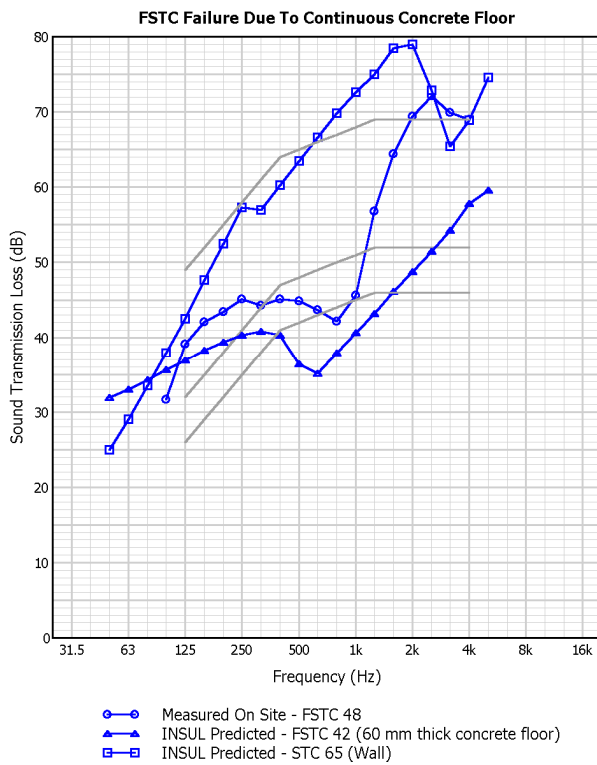
Figure 6A: Double Timber Stud
INSUL Predicted - STC 65 Wall

The wall construction was similar to that of the Winstone Gib GBT (L)A 30b (refer Table 1) with an additional layer of 13 mm Gib Toughline attached to the side with one layer of 10 mm Noiseline. The measured performance of the above Winstone double timber stud wall is STC 58 and with the additional layer of 13 mm Gib Toughline the SIPS rating is STC 65 as described and shown in Figures 6A and 6B.

Figure 6A shows the SIPS predicted performance for a 60 mm thick concrete floor which has a noticeable coincidence dip in its sound transmission loss at 630 Hz.

The shape of 60 mm thick concrete floor sound transmission loss curve below and above this coincidence frequency dip closely approximates that of the measured on-site performance of the failed wall system. Follow up vibration measurements on the floor, wall and adjacent perimeter walls and ceiling confirmed that the concrete floor was the controlling noise transmission path in this instance.

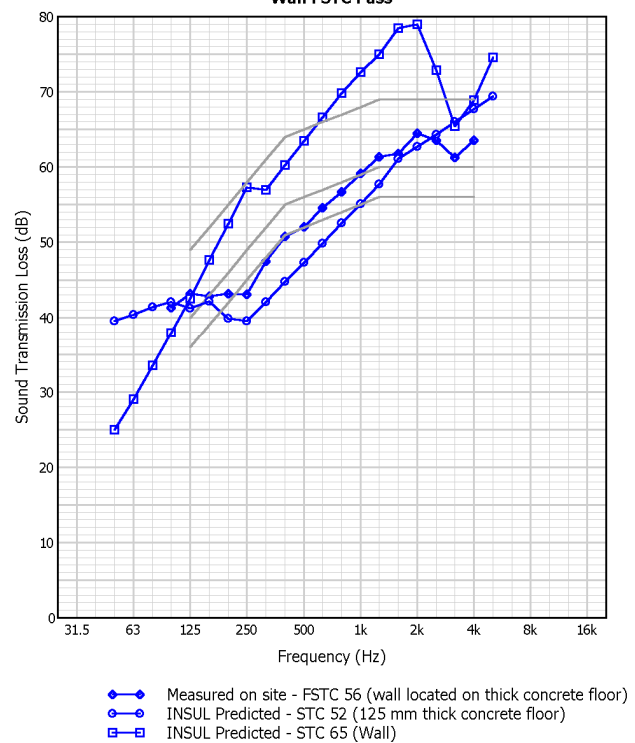
Figure 6B: Double Timber Stud
INSUL Predicted - STC 65 Wall
Wall FSTC Pass

Figure 6B describes the results for the same wall construction that was located over a concrete beam, which achieved a rating of FSTC 56. The sound transmission loss curve for this on-site result above 250 Hz appears to follow the SIPS performance curve for the wall construction. Also shown in Figure 6B is the SIPS predicted rating of STC 52 for a 125 mm

thick concrete floor and, again, this appears to closely approximate that TL curve for the on-site FSTC 56 floor.

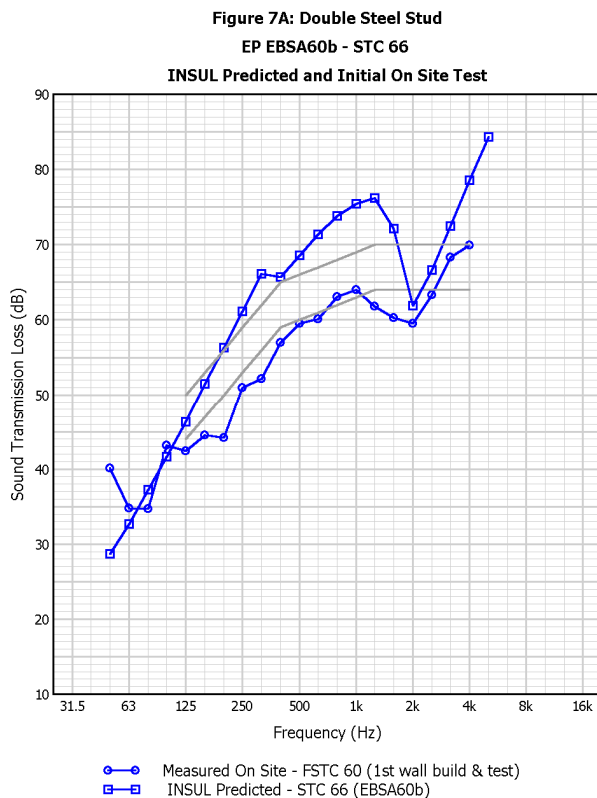
The SIPS prediction for this wall construction is STC 66 and is described in Figure 7A. The first wall construction was tested on-site and a favourable measured result of FSTC 60 was obtained as described in Figure 7A.

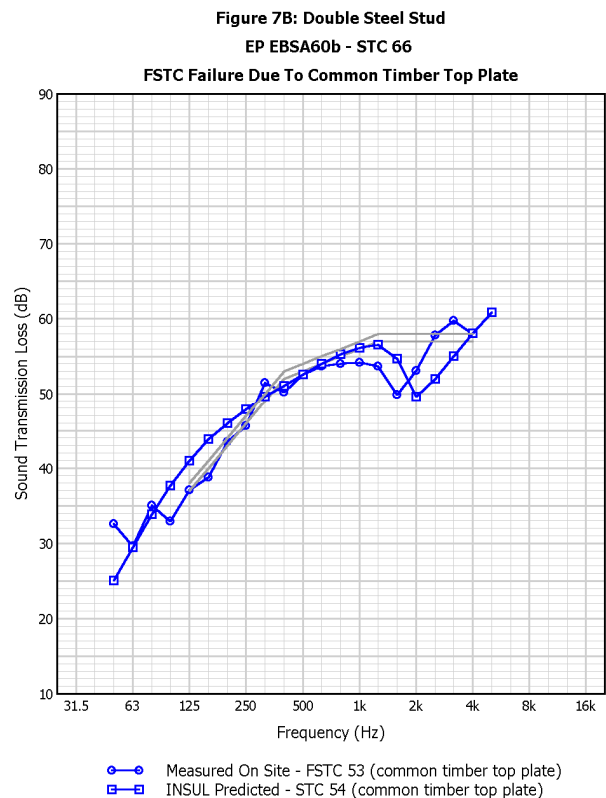
As the building works progressed further on-site tests were carried out and typical results of around FSTC 53 to 54 were obtained and are described in Figure 7B.

The SIPS predicted rating for this modelled wall, FSTC 54, is also shown in Figure 7B. The construction modelled is based on the double steel stud wall being

connected by a common timber top plate (i.e. a 150 x 25 mm timber plate that was in turn directly fixed to a major steel beam). The sound transmission loss curves for the on-site measured levels and the SIPS predictions appear to mirror each other throughout the test spectrum range except for a slight octave difference in the coincidence frequencies.

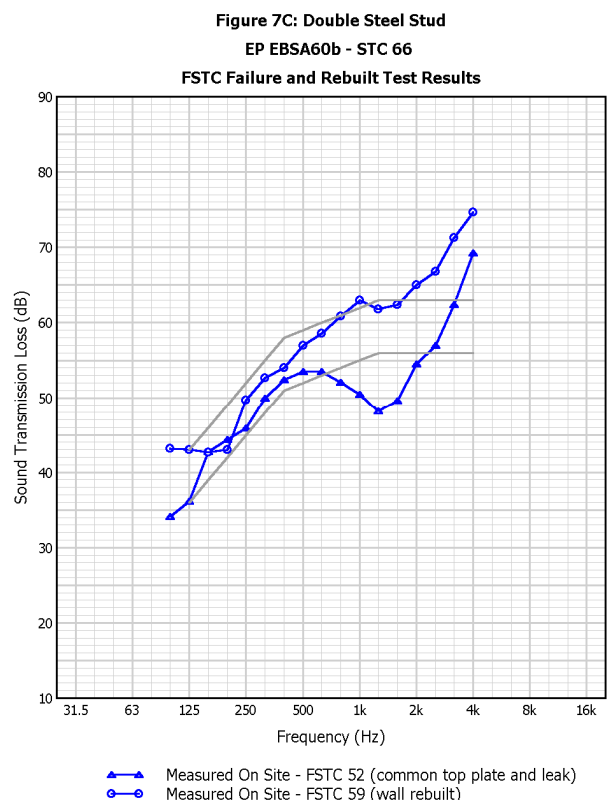
Another on-site measurement (FSTC 52) of a wall which had a common top plate and some high frequency leakage is shown in Figure 7C.

Following a rebuild of this wall, which involved the separation of the

common timber plate and sealing the wall perimeter, a very satisfactory on-site result of FSTC 59 was achieved. These results are described in Figure 7C.

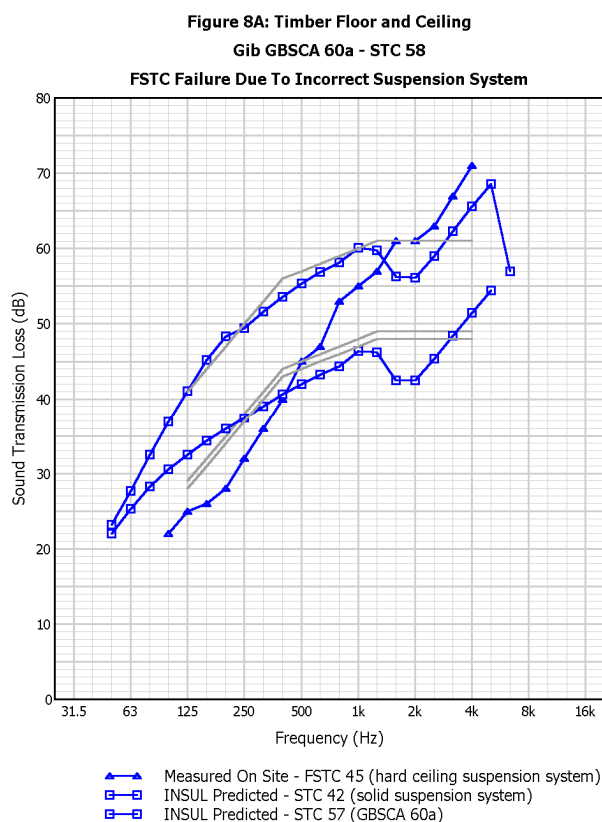
On a project where a Winstone Gib GBSCA 60a timber floor and ceiling system was specified (refer Table 1), the on-site results indicated a major failure of the construction.

The on-site result of FSTC 45 revealed a significant problem and non-conformance with the minimum Building Code criterion. The results are described in Figure 8A, including those for the SIPS prediction of the wall performance.

Also shown in Figure 8A is the prediction of the same wall with the ceiling linings hard connected to the floor joists. The SIPS prediction is not as satisfactory as one would like and can be

explained by the fact that:

- the ceiling suspension system used is not an equivalent or equal to that recommended by Gib, and,
- there is a major resonance effect occurring below 400 Hz which at this stage cannot be modelled by the SIPS.

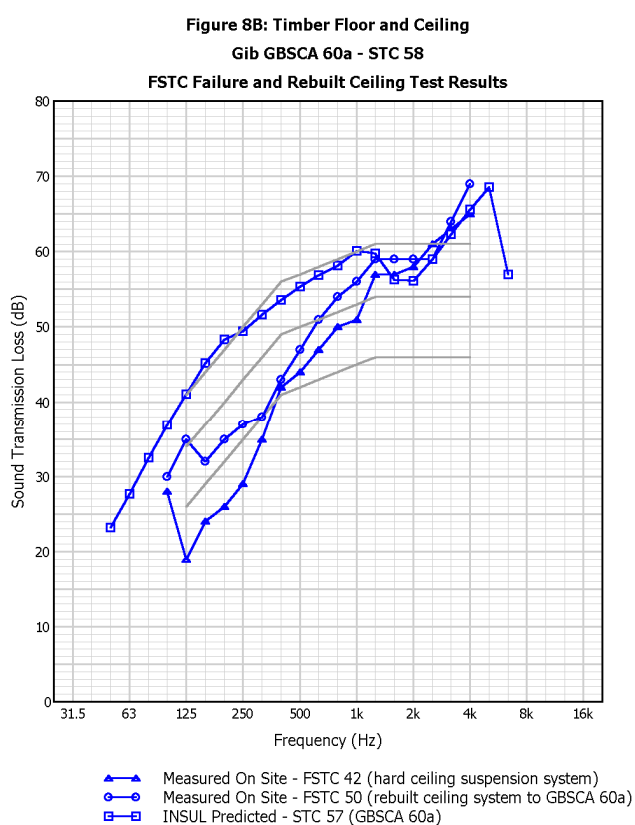
The results of another floor/ceiling system in the building is also shown in Figure 8B, before and after rectification works, which showed an improvement from FSTC 42 to FSTC 50 following installation of the correct resilient suspension system as specified by Gib.
