# Wind Turbine and Wind Farm Sound Levels: A Prototype Journey

Geoff Henderson

CEO, Windflow Technology Ltd, Christchurch, New Zealand

*A paper previously presented at the 2006 NZAS/AAS 2006 societies conference "Noise of Progress"*

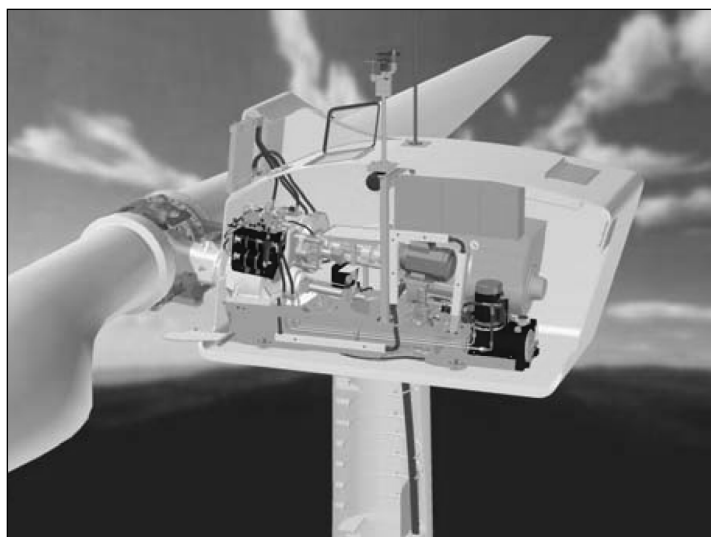
Figure 1. Windflow 500 Turbine

Our turbine has a 33 m rotor and a rating of 500 kW. It combines two proven technologies based on the author's experience in Britain in the 1980's:

- two bladed teetering with pitch-teeter coupling
