# Control of Aeolian Noise Generated by the Finned Balustrade of a Freeway Pedestrian Overpass

Andrew Mitchell (1), Dr Damien Leclercq (2) and Matthew Stead (3)

## Abstract

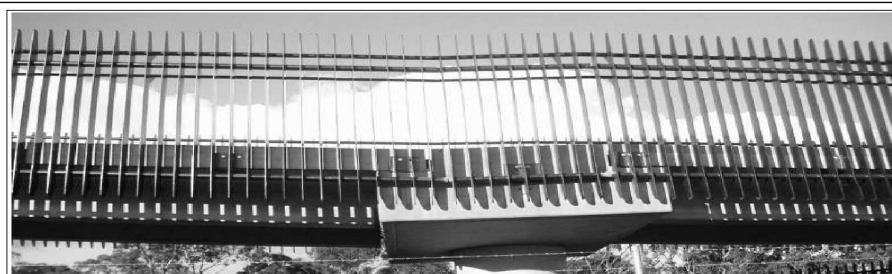
The balustrades consisted of a series of vertical fins spaced at 125mm centres, with cylindrical horizontal supports near the top and bottom. Each fin was constructed from 6mm thick steel plate, and was approximately 2m long and 125mm deep. A typical balustrade is shown in Figure 1.

Figure 1 – Finned Balustrade of Pedestrian Overpass

Under the wind conditions where the noise was observed to occur, the tonal noise generated by the balustrades was measured to be up to 40 dB above the residual noise levels. This level of noise was unacceptable at residences neighbouring the overpasses, and was unlikely to be sufficiently masked by traffic noise once the freeway was operational. A solution to reduce the level of wind-induced noise was therefore required, for implementation

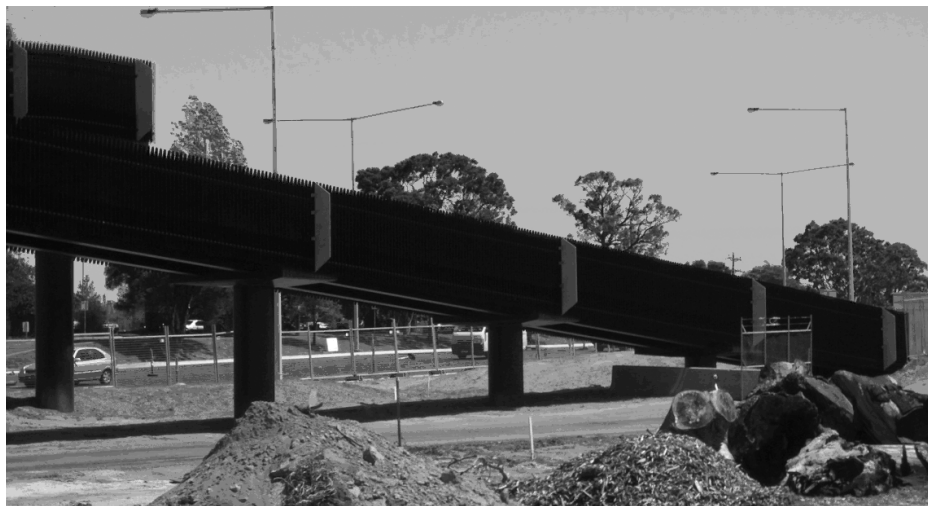
In a parallel effort to the wind tunnel tests and modelling carried out by the University of Adelaide, a series of temporary 400mm wide fin extensions were manufactured from plywood and installed on one of the affected pedestrian overpasses at a spacing of approximately one extended fin every 5m (40 fins) as shown in Figure 14

Re-occurrences of the noise under the same wind conditions following the installation of the fin extensions indicated that the fin extensions were not having any significant effect on the airflow across the majority of the balustrade.

**Figure 14 –Balustrade Fin Depth Extensions Installed on a Pedestrian Overpass**

It is possible that decreasing the spacing of the extended fins to one every 0.4 to 0.5m (every 3 to 4 balustrade fins) may have made this approach more successful, as increased sheltering of the unmodified fins from the wind would have resulted.

However, this closer spacing was not deemed acceptable in terms of the urban design or the labour and cost that would be involved to complete the modification, so the idea was abandoned.
